Local Concept Development Study for Cape May County Route 619 (Ocean Drive) Bridge (Structure No. 3100-003) Located over Townsends Inlet

Sea Isle City and Borough of Avalon

# Navigation Impact Report

MARCH 2026

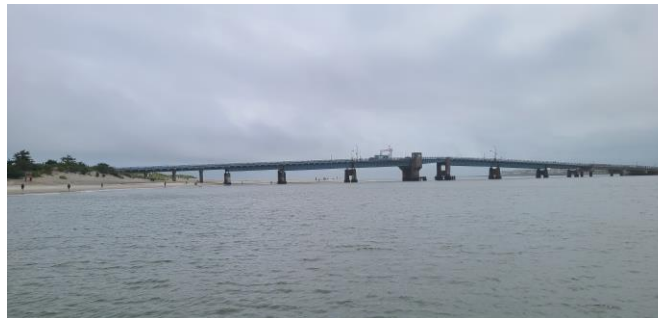
*Figure 2. Townsends Inlet Bridge with closed bascule (8/20/2025)*

The substructure consists of reinforced concrete piers on timber piles. The vertical under clearance at the bascule span is approximately 23' to the mean high-water (MHW) line with a 50' horizontal clearance for navigational purposes.

- Structure Type: Steel bascule bridge with 23-fixed approach spans composed of a mixture of steel multi-girder spans, prestressed concrete girder spans, and girder-floor beam-stringer systems with reinforced concrete decks and one single leaf bascule span.
- Structure Length: 1373.0'
- Width Out to Out: 25.33'
- Width Curb to Curb: 20'
- Sidewalk: 1.5' width safetywalk on both sides of the bridge
- Fence: Four-bar bridge railing on both sides of the bridge
- Lighting: Lighting is present at both bridge approaches, at the toll booth, and the traffic signal. All lights are standard cobra head style lights. Lighting on the bridge is located on standard metal poles and lighting on each approach roadway co-located on existing utility poles.

- Vertical Clearance: Waterway navigational 23' minimum below closed bascule at mean high tide. Unlimited vertical clearance with open bascule (not currently operational).
- Horizontal Clearance: 50 feet below the bascule span.
